### **Swordfish racing dinghy no. 196 built c 1947 by Fairey Marine Ltd. in Hamble.**

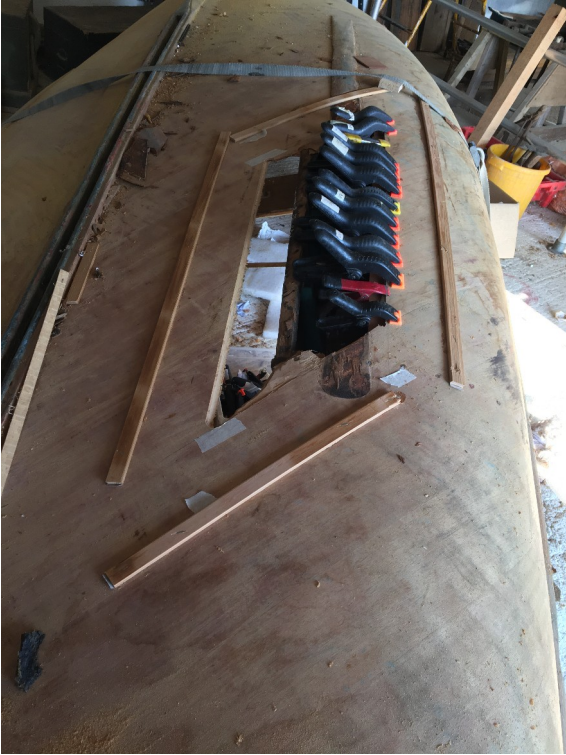
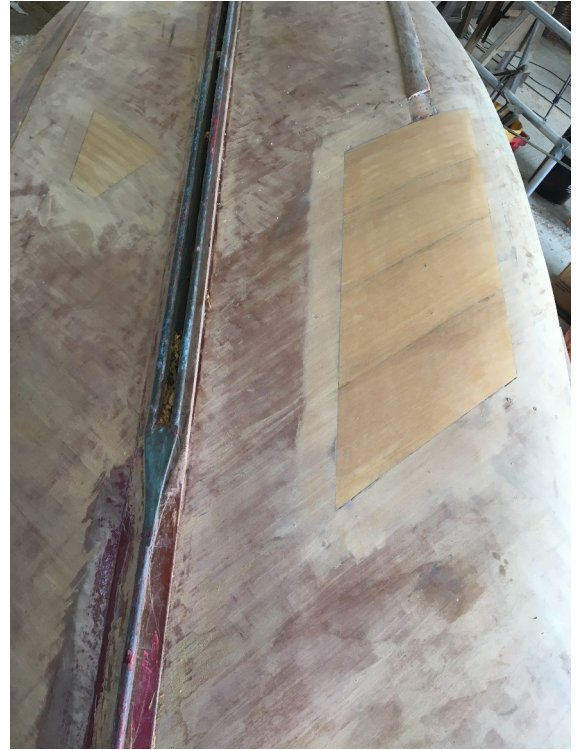
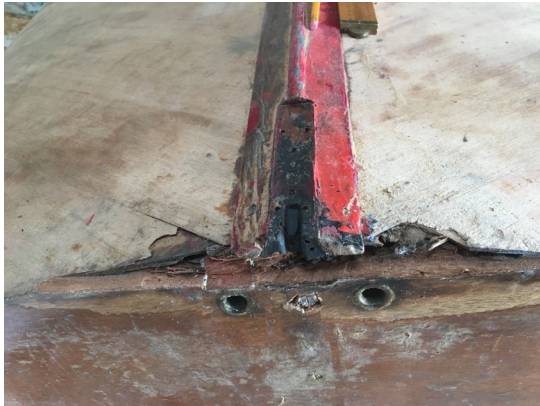
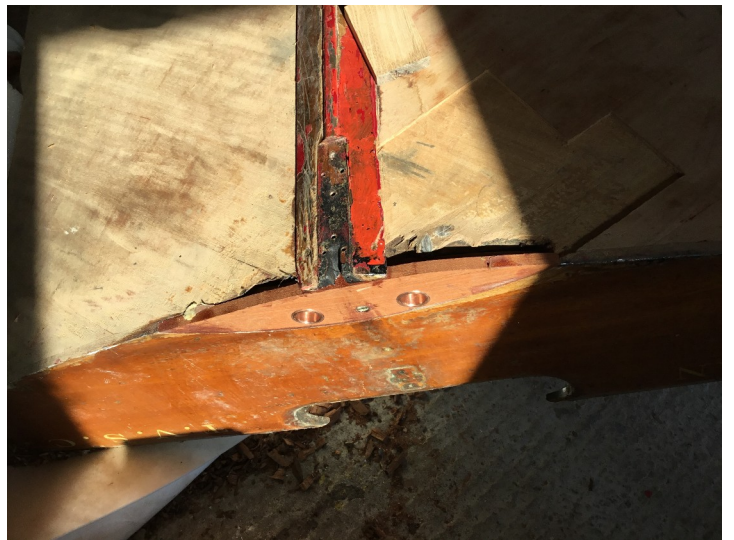
The WWMHS owns a Firefly and a rarer Swordfish which is currently being restored to sailing condition. Some holes in the hull have been repaired using three layers of 2.5mm veneer; old paint and varnish has been stripped off ready for a new finish. The old deck, made from 6mm plywood, was in a very poor condition and has been scrapped and removed ready for a new deck. The lowest part of the mahogany transom was rotten so new timber has been spliced in there. I'm currently waiting for the warmer, drier weather before varnishing and some other work, which will ensure the buoyancy tanks are watertight again.
